Giving new life to historic towns: Rehabilitation of Malta's walled towns

MDINA – A CASE STUDY

Restoration and Rehabilitation of the Historical Fortifications of Malta and Gozo

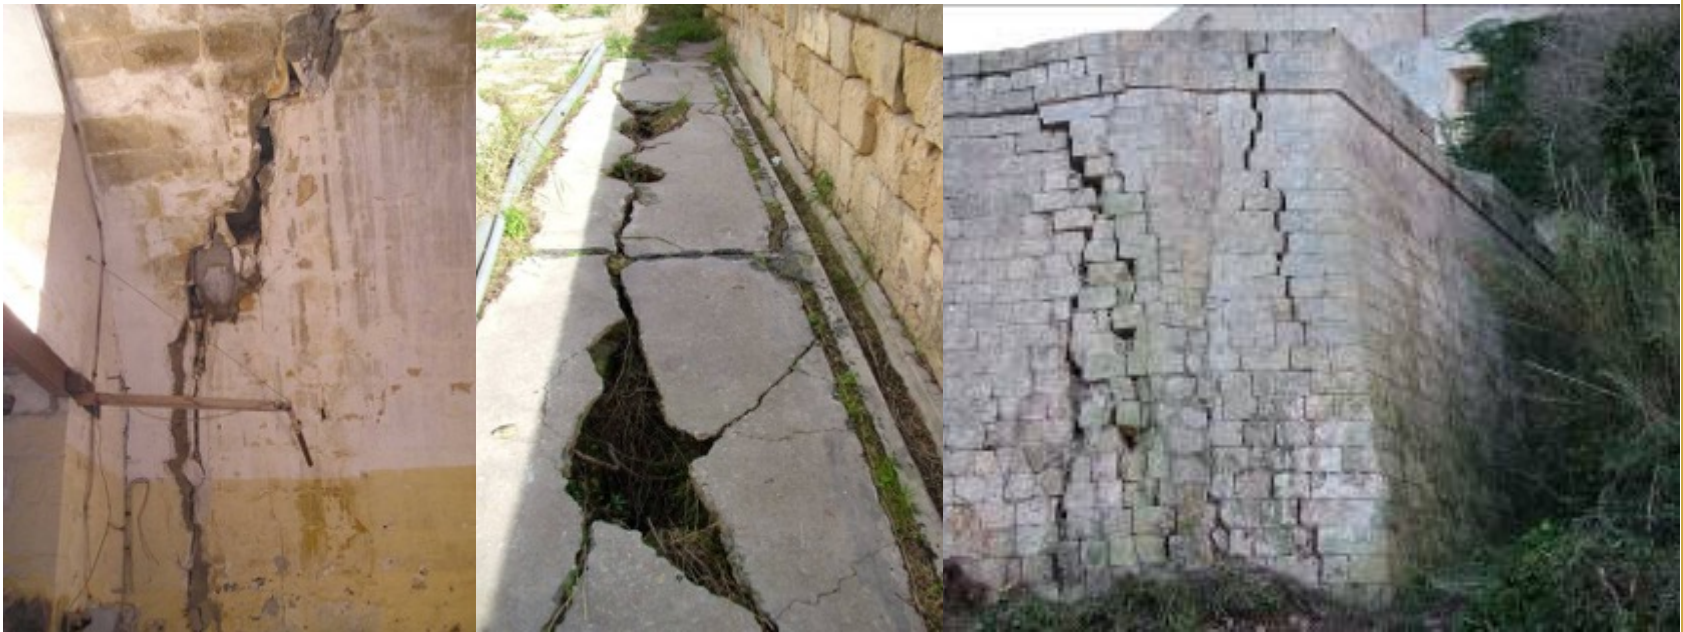
Identification of the damage

The structural problems of the Mdina bastions, in particular in the area underlying Vilhena Palace, had long been recorded. In the past, various attempts to resolve this delicate situation were undertaken and, although several reports were drawn up, no interventions had been carried out.

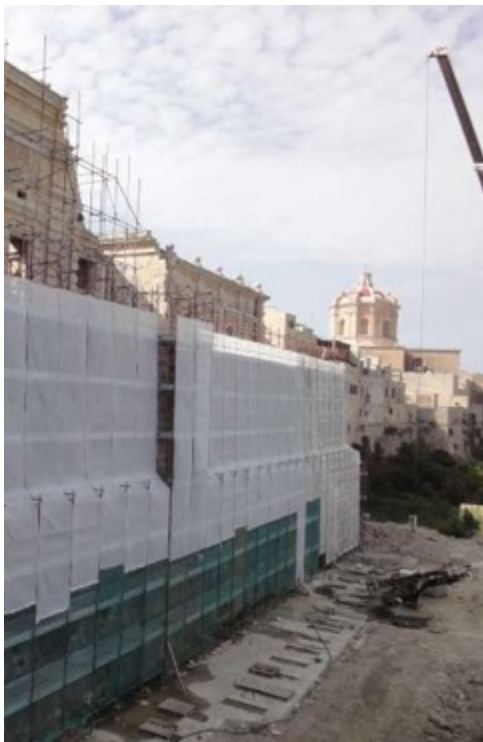
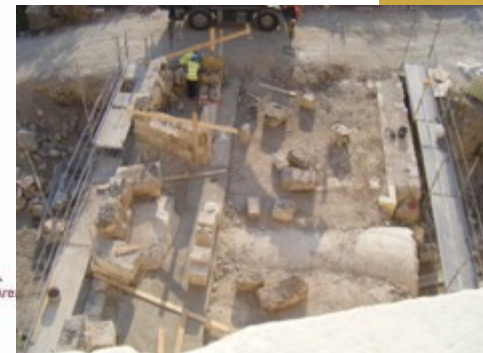
In Mdina interventions were limited to the most endangered areas, namely the areas underlying Vilhena Palace and St. Paul's Bastion (Intervention Area A) , Despuig Bastion (Area B) and Magazine Curtain (Area C).

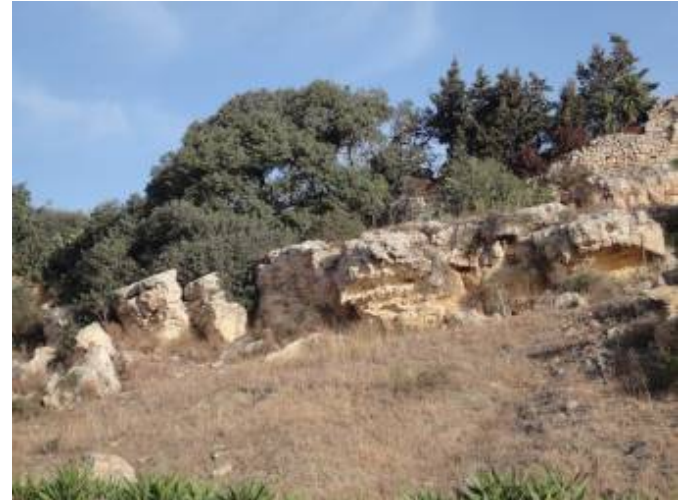
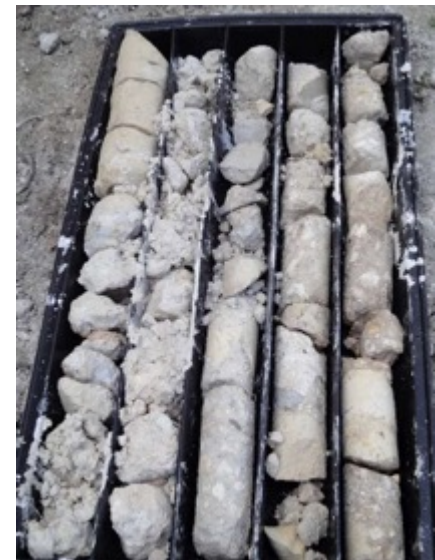
Identifying the failure mechanism

THE GEOLOGY OF THE AREA

All the tests confirmed the existence of active ground. In particular areas both ramparts and the overlying structures, particularly those located along the peripheral areas with their foundations resting upon the hidden cliff-face, were all being subjected to hidden pressures from the shifting ground. The principal mode of failure was observed to be rigid body rotation about the foot of the ramparts' foundations, with toppling at the top due to yielding of the underlying clay strata.

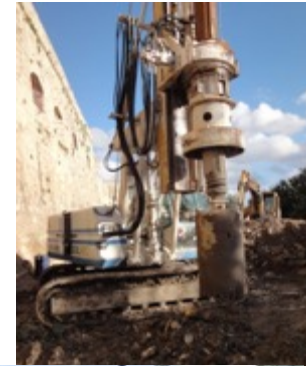
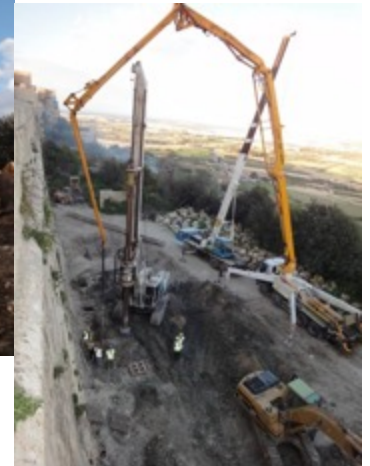
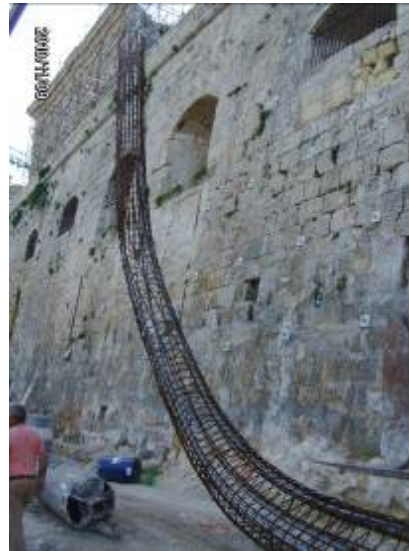
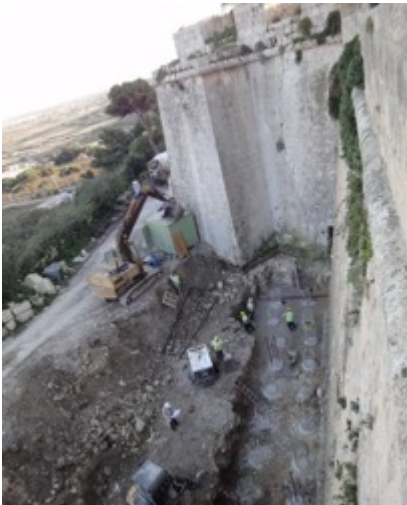
Mdina ground consolidation – Vilhena Palace Area

Ground Consolidation of the Vilhena Palace area was based on four different types of structural interventions, which were executed in the following sequence:

- 16m deep Steel Anchor Bars, consolidating and anchoring wall masonry;
- 15m Micropiles, at foundation base, reinforcing foundation soil and preventing shear deformations in surface layers
- 16m deep large diameter bored piles, with capping beam to transfer loads from upper layers to deeper stiffer soil;

- 26m deep post-stressed anchors, connecting the piles to more stable ground, preventing further movement

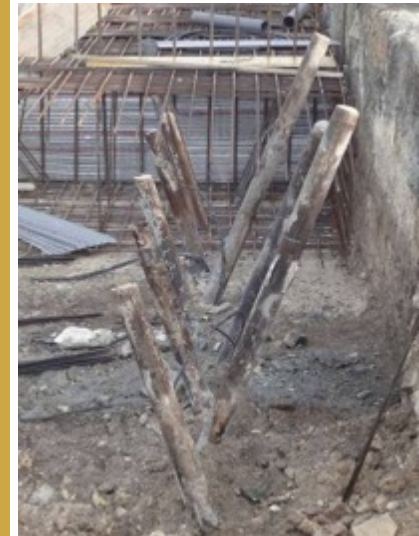
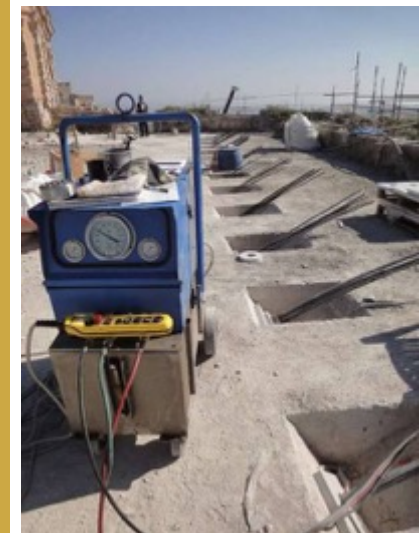
Mdina ground consolidation – St. Paul's Bastion

In the St. Paul's Bastion area, ground consolidation works were therefore carried out from the top of the bastion level, and included the insertion of vertical and inclined micropiles to a depth of 36m and prestressed strand tendons reaching a depth of 16m. A capping beam 1.5m deep transfers the forces created in the micropiles and in the strand anchors to the masonry structure of the historic walls.

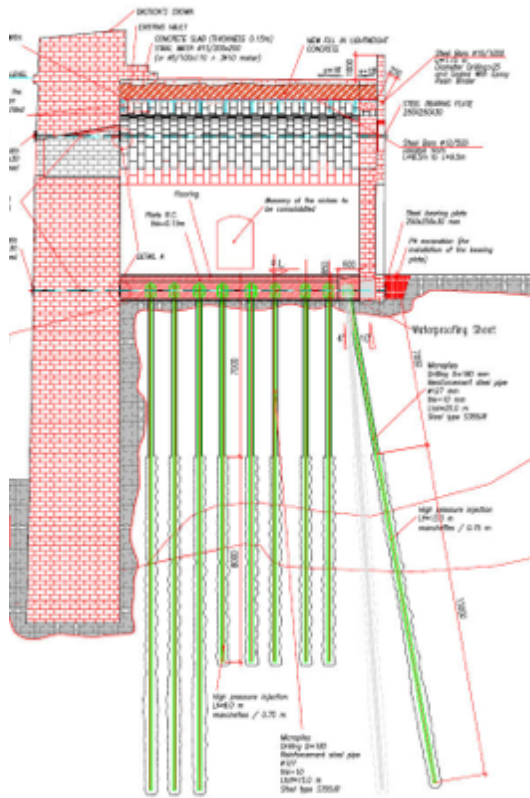
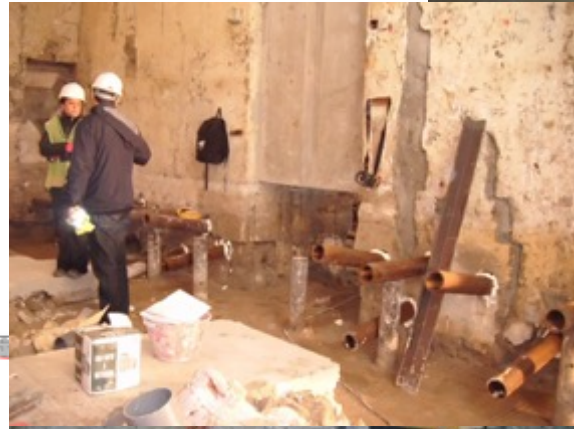
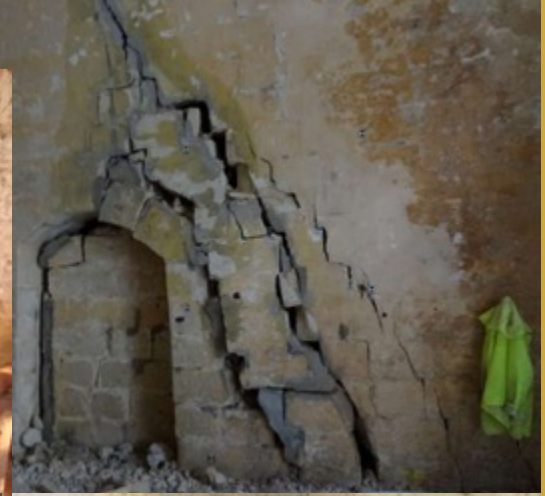
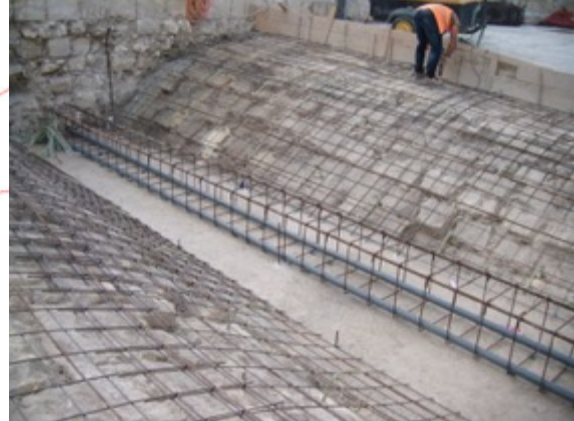
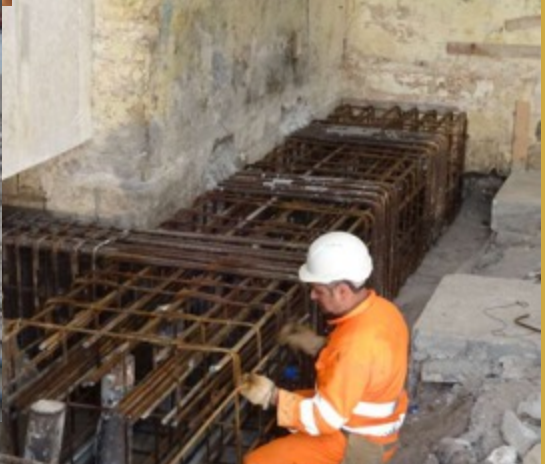
Mdina ground consolidation Magazine Curtain

Magazine Curtain represented perhaps the most dangerous section of the ramparts. Huge fissures cutting through barrel vaults were threatening to bring down many of the magazines. A series of piles inserted on either side of the Vault walls were stitched together by means of capping beams running the perimeter of the magazines. The barrel vaults were also stitched and consolidated from above.

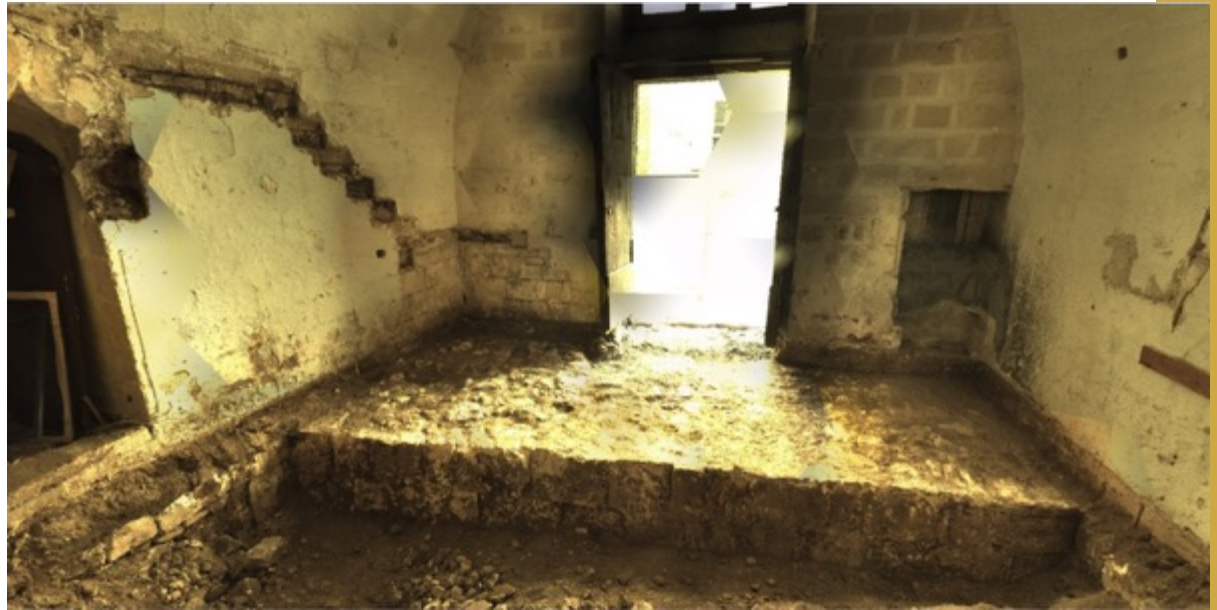
**Mdina ground consolidation
Magazine Curtain**

**The old fortification
wall was discovered
during the
excavation for trial
pits**

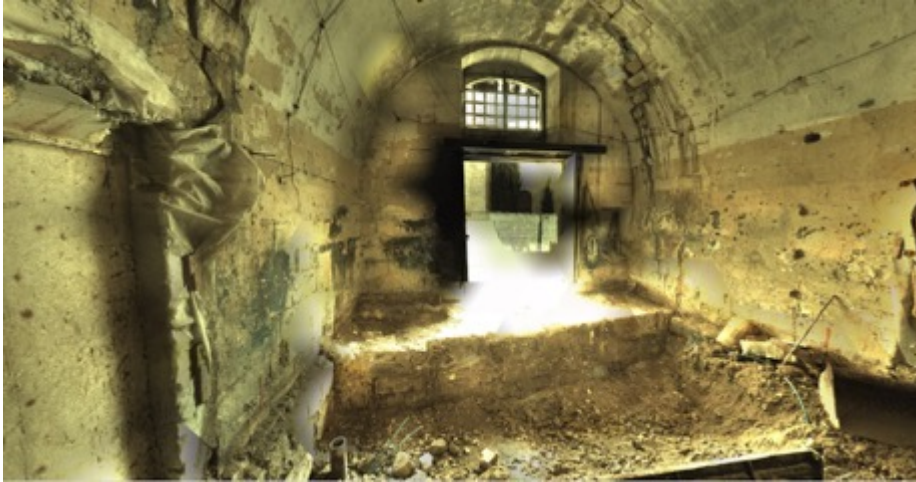
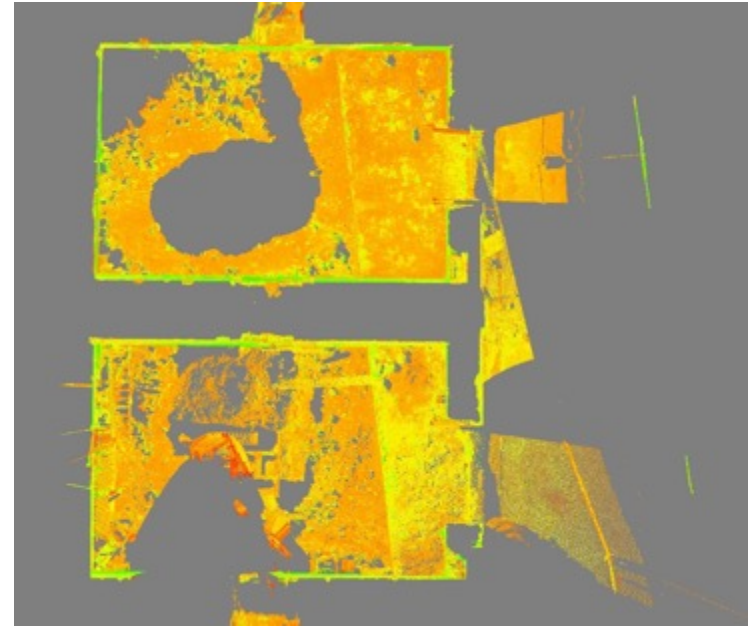
**Mdina ground
consolidation
Magazine
Curtain**

**Laser scans of
the
archaeological
finds where
carried out**

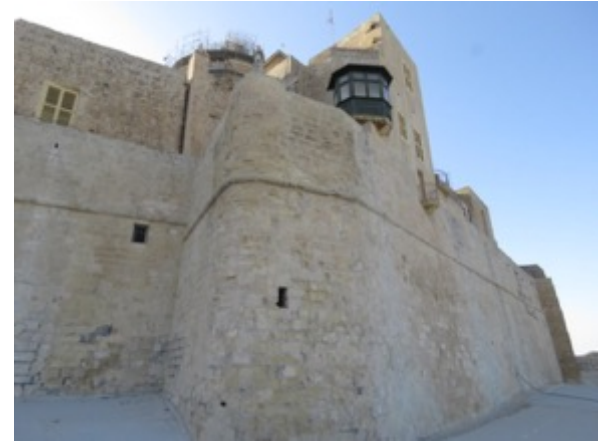
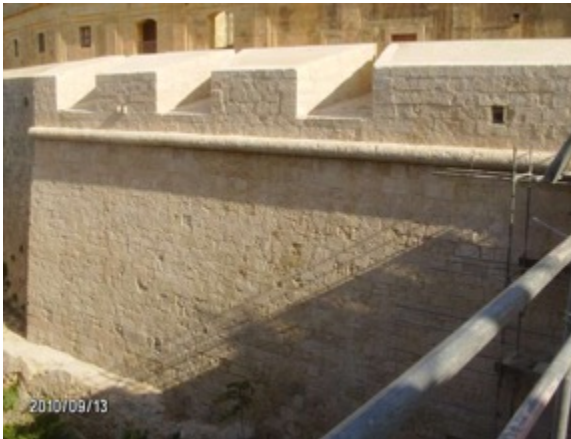
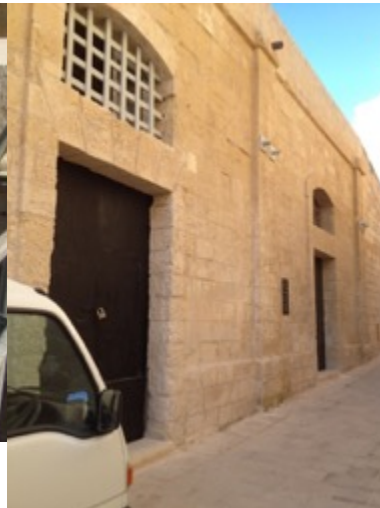
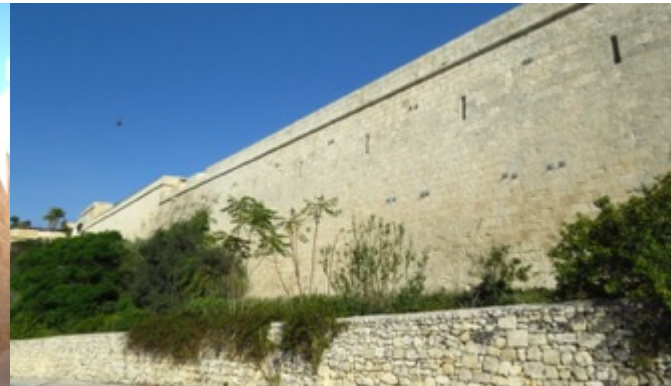
Restoration of the fabric

As the consolidation works progressed, the restoration works on the stone fabric followed soon after.

Each section of each and every, wall, rampart and bastion was surveyed, drafted, and painstakingly mapped for deterioration processes and interventions before it was brought into the state of restoration and preservation it is in today.

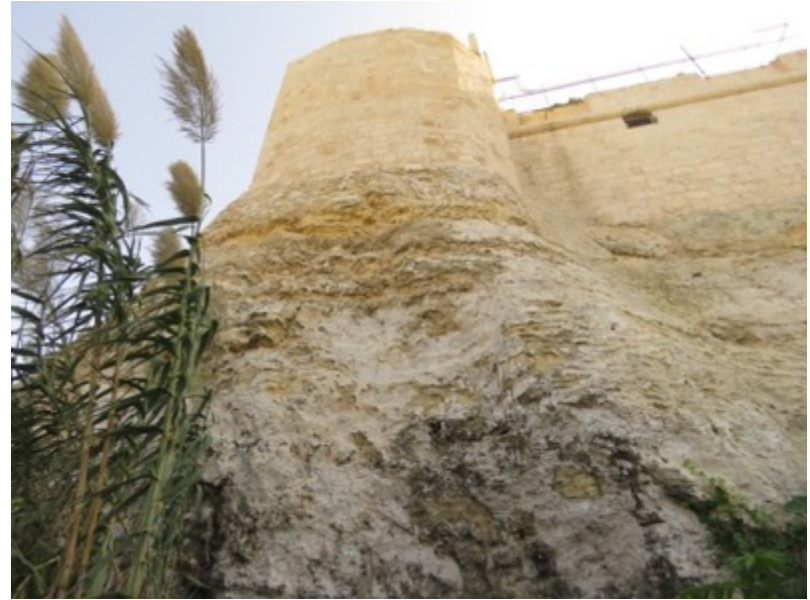
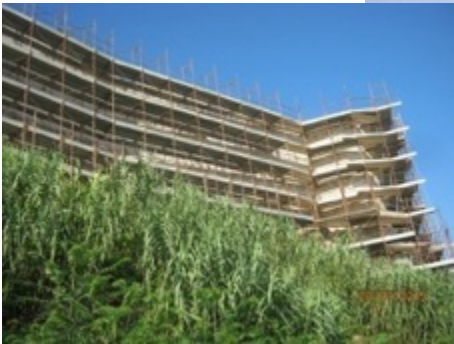
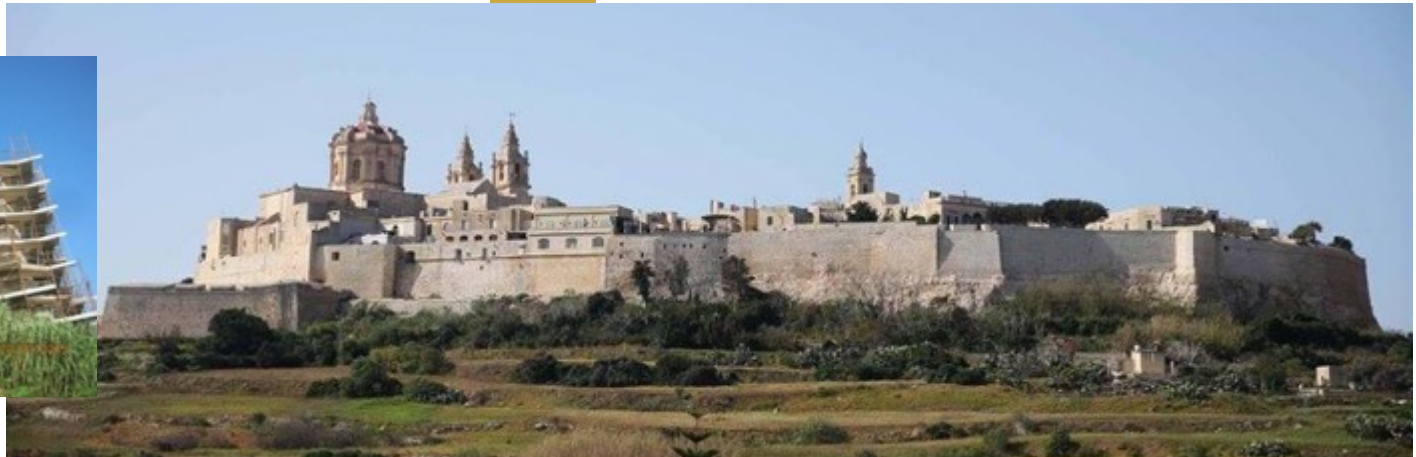
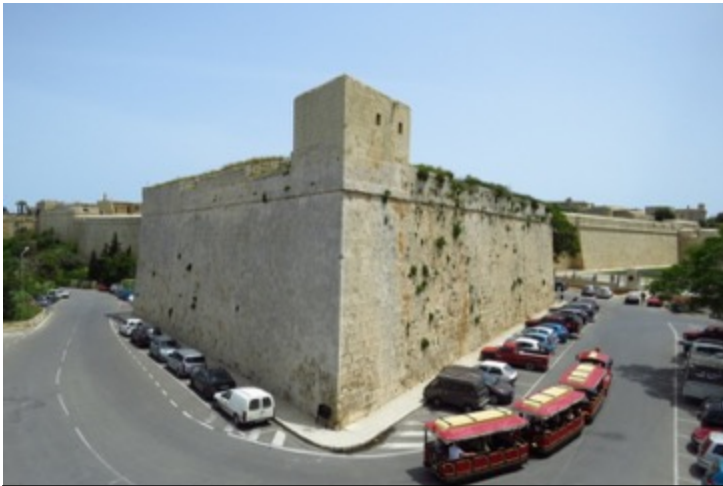
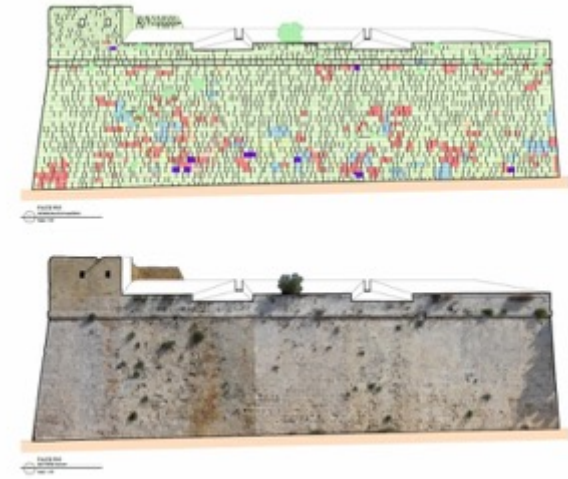
Restoration at St. Mary's Bastions

In 2013, the Restoration Directorate put forward another request for funds to Managing Authority to be able to complete the perimeter of the Medieval city within the latest possible phase of application. This request was accepted and the tenders for the restoration of St. Mary's bastion and the adjoining medieval ramparts as well as St. Peter's Bastions were published and awarded.

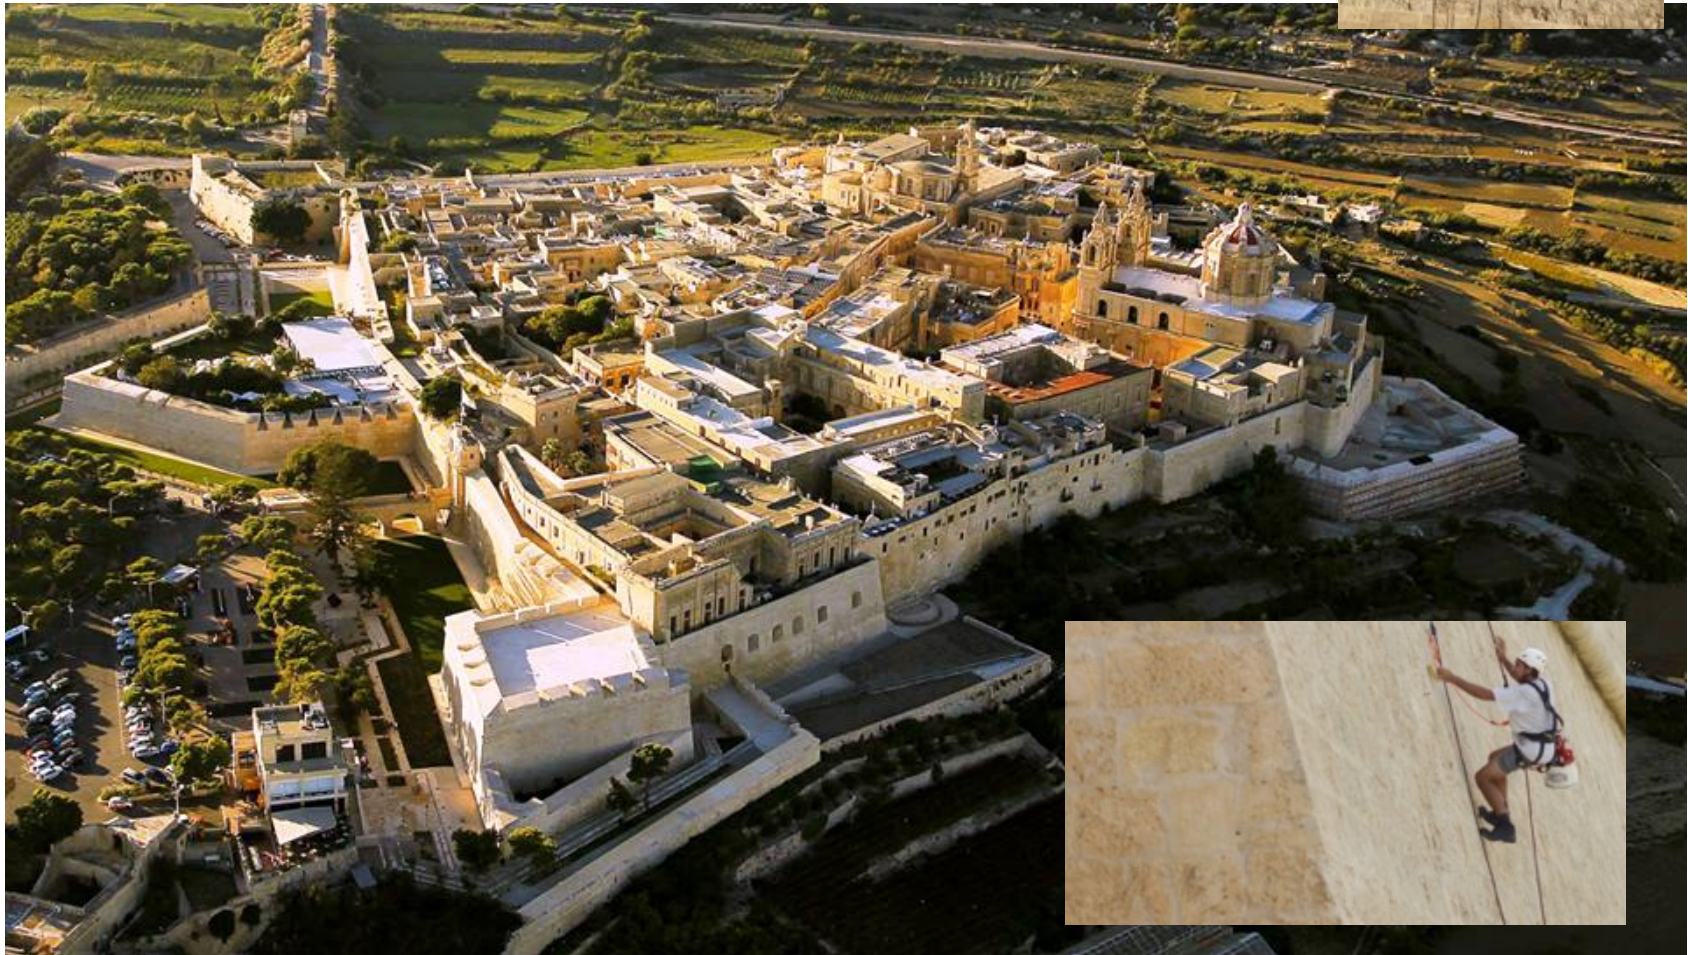
The maintenance team

Thus the whole perimeter of fortifications of Mdina was finally completely restored and consolidated by January 2016. The Restoration Directorate has brought together its own maintenance team, made up mainly of abseiling personnel trained in restoration techniques, to be able to maintain the restored ramparts.
